## WOODLAND PARK APARTMENTS

### ADDENDUM #02A

## **ATTIC REMEDIATION PROTOCOL**

Subject Property: Woodland Park  
280 SE 12<sup>th</sup> Avenue  
Portland, Oregon

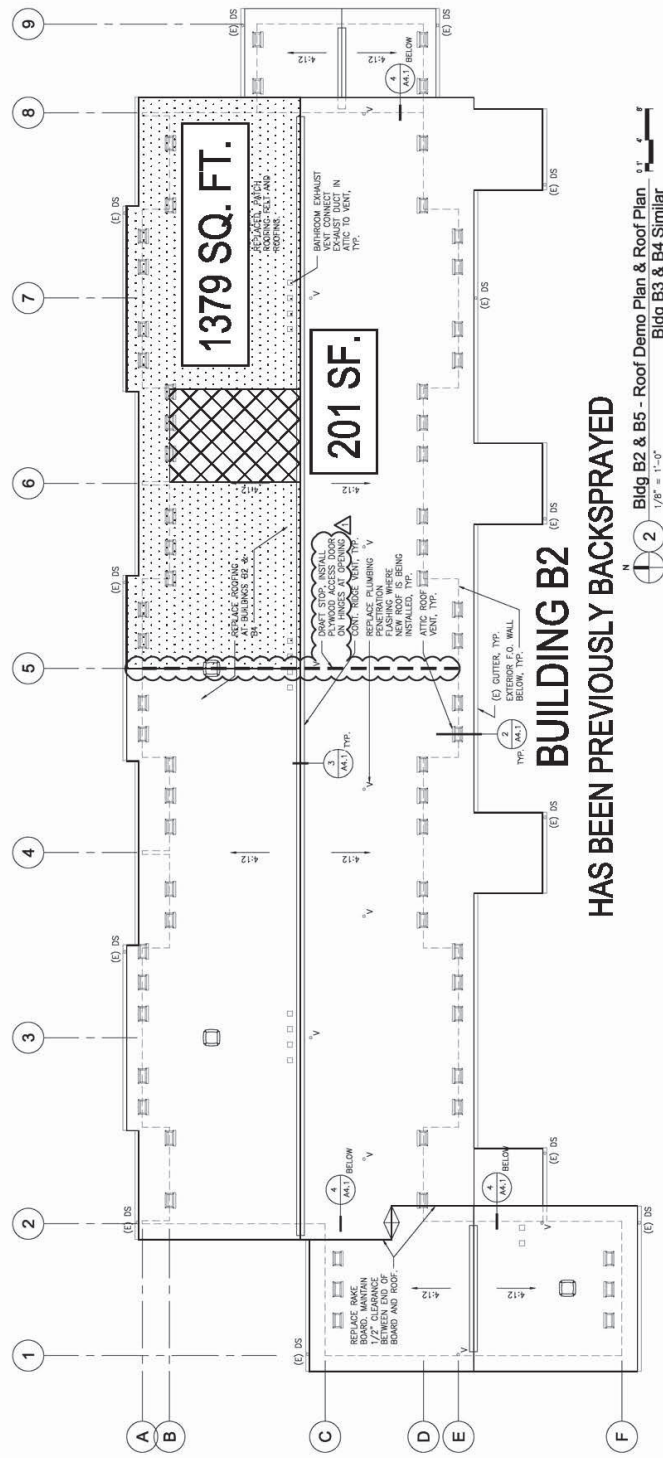
**BUILDING B2  
HAS BEEN PREVIOUSLY BACKSPRAYED**

**HEAVY CONCENTRATED DAMAGE: 201 SQ. FT.**  
THE AREA IS COVERED IN GROWTH WITH LARGE AREAS OF ROT AND DELAMINATION OF PLYWOOD.

**GENERALIZED DAMAGE: 000 SQ. FT.**  
A LIGHT COVER OF GROWTH THROUGHOUT THE AREA.

**UN-CONCENTRATED DAMAGE: 1379 SQ. FT.**  
GROWTH AREA WITH SMALL AREAS OF ROT AND DELAMINATION OF PLYWOOD. LIGHT GROWTH IN SPOTS UN-CONCENTRATED.

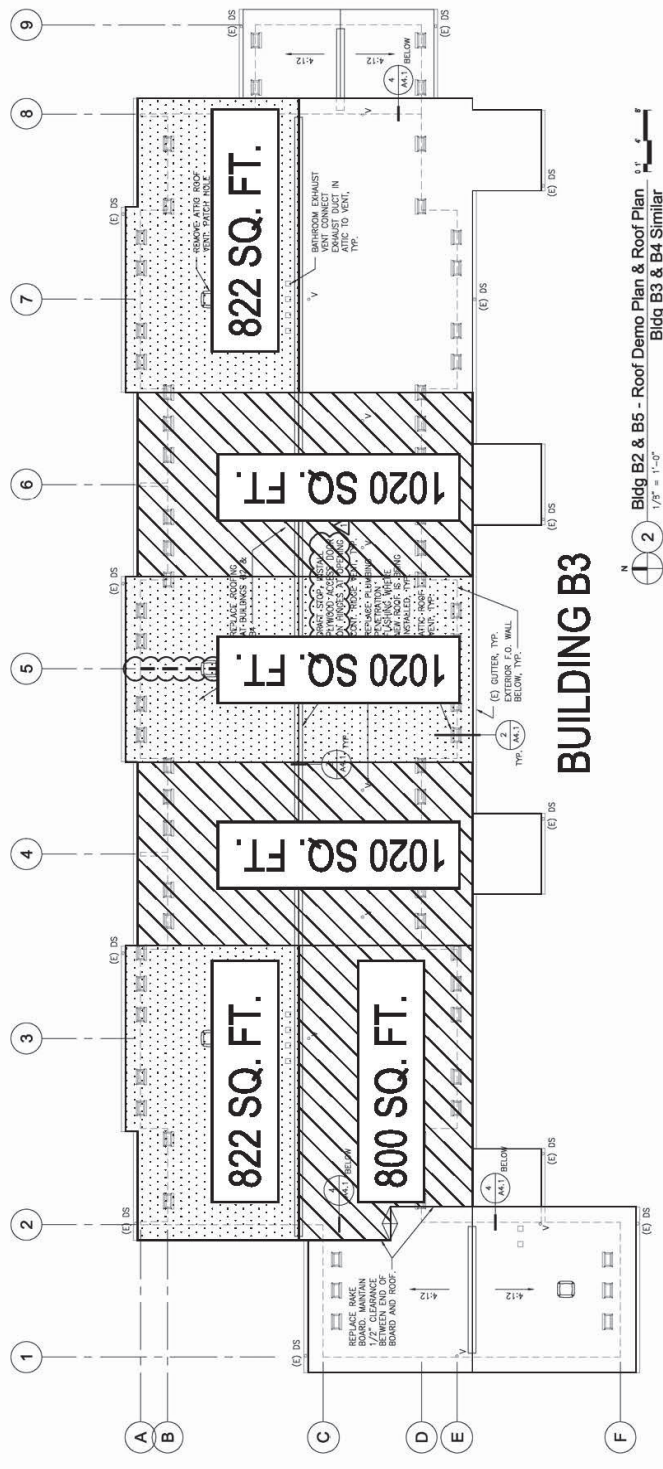
**BUILDING B3**

**HEAVY CONCENTRATED DAMAGE:** 000 SQ. FT.

THE AREA IS COVERED IN GROWTH WITH LARGE AREAS OF ROT AND DELAMINATION OF PLYWOOD.

**GENERALIZED DAMAGE:** 2840 SQ. FT.

A LIGHT COVER OF GROWTH THROUGHOUT THE AREA.

**UN-CONCENTRATED DAMAGE:** 2711 SQ. FT.

GROWTH AREA WITH SMALL AREAS OF ROT AND DELAMINATION OF PLYWOOD. LIGHT GROWTH IN SPOTS UN-CONCENTRATED.

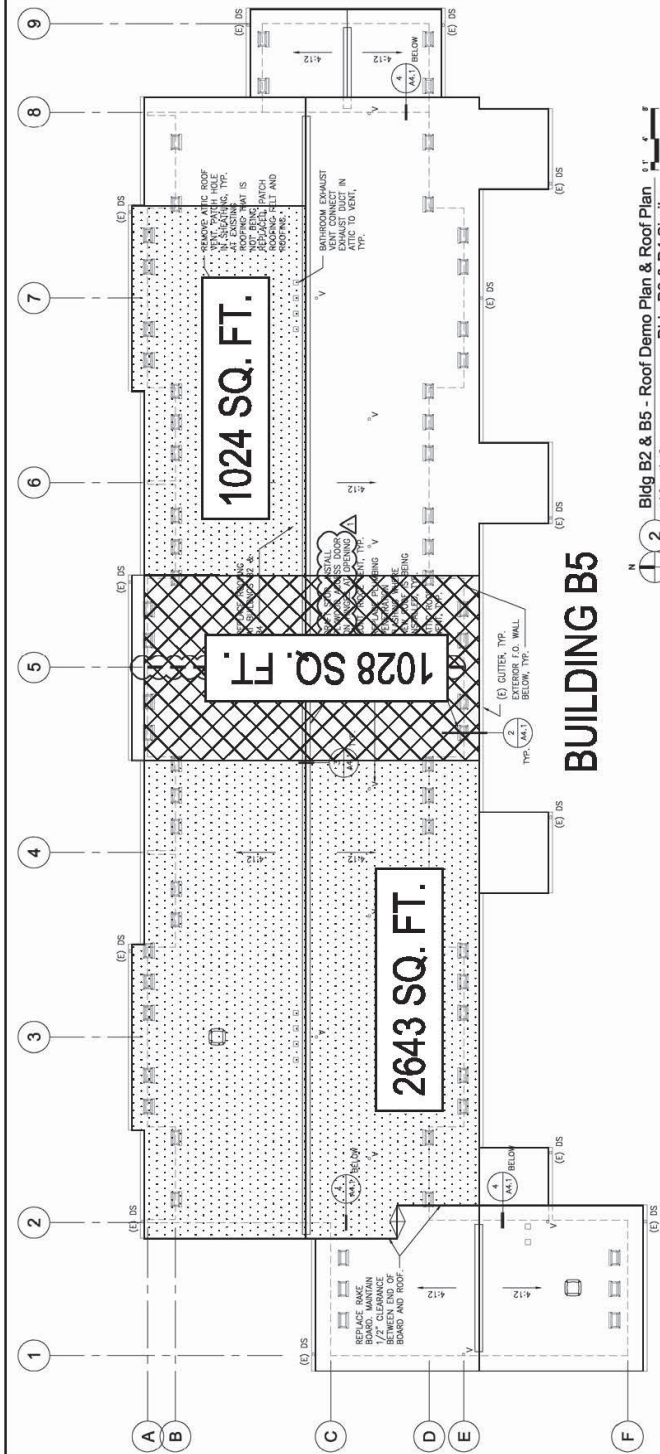
**BUILDING B5**

**HEAVY CONCENTRATED DAMAGE:** 1028 SQ. FT.

THE AREA IS COVERED IN GROWTH WITH LARGE AREAS OF ROT AND DELAMINATION OF PLYWOOD.

**GENERALIZED DAMAGE:** 000 SQ. FT.

A LIGHT COVER OF GROWTH THROUGHOUT THE AREA.

**UN-CONCENTRATED DAMAGE:** 3667 SQ. FT.

GROWTH AREA WITH SMALL AREAS OF ROT AND DELAMINATION OF PLYWOOD. LIGHT GROWTH IN SPOTS UN-CONCENTRATED.

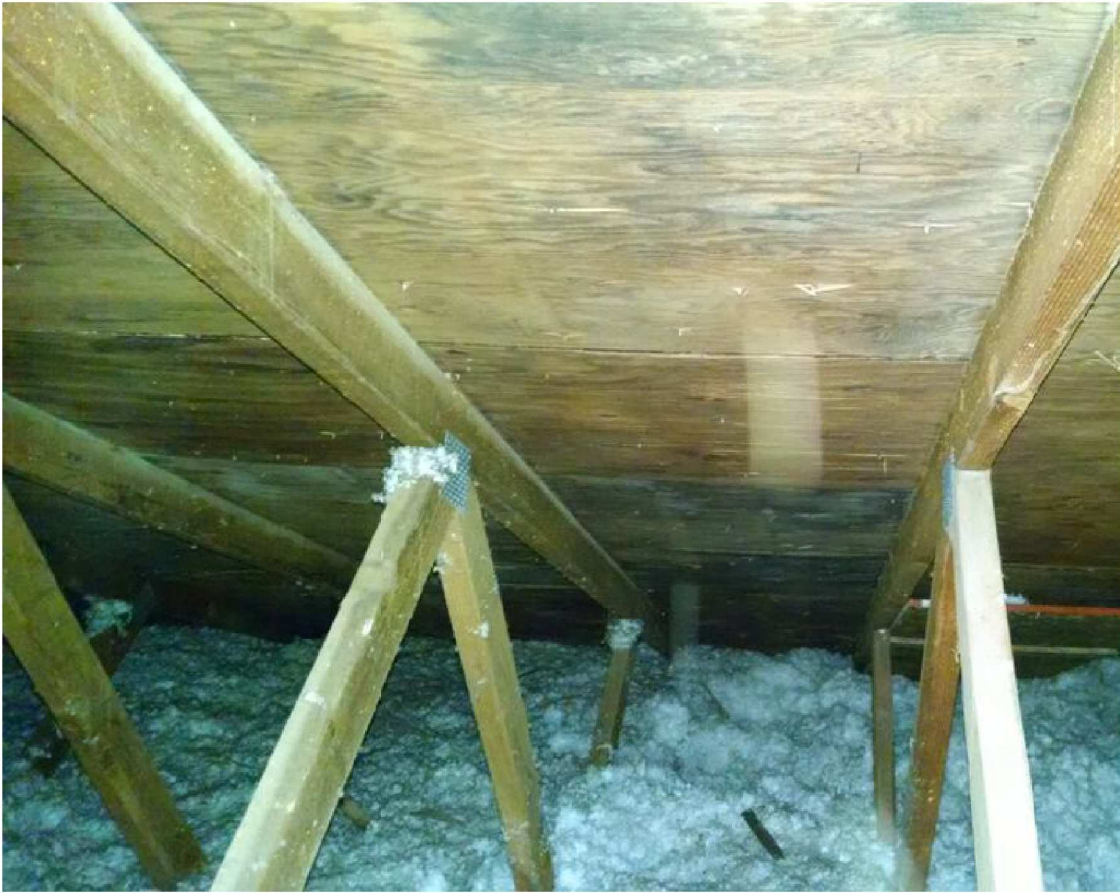
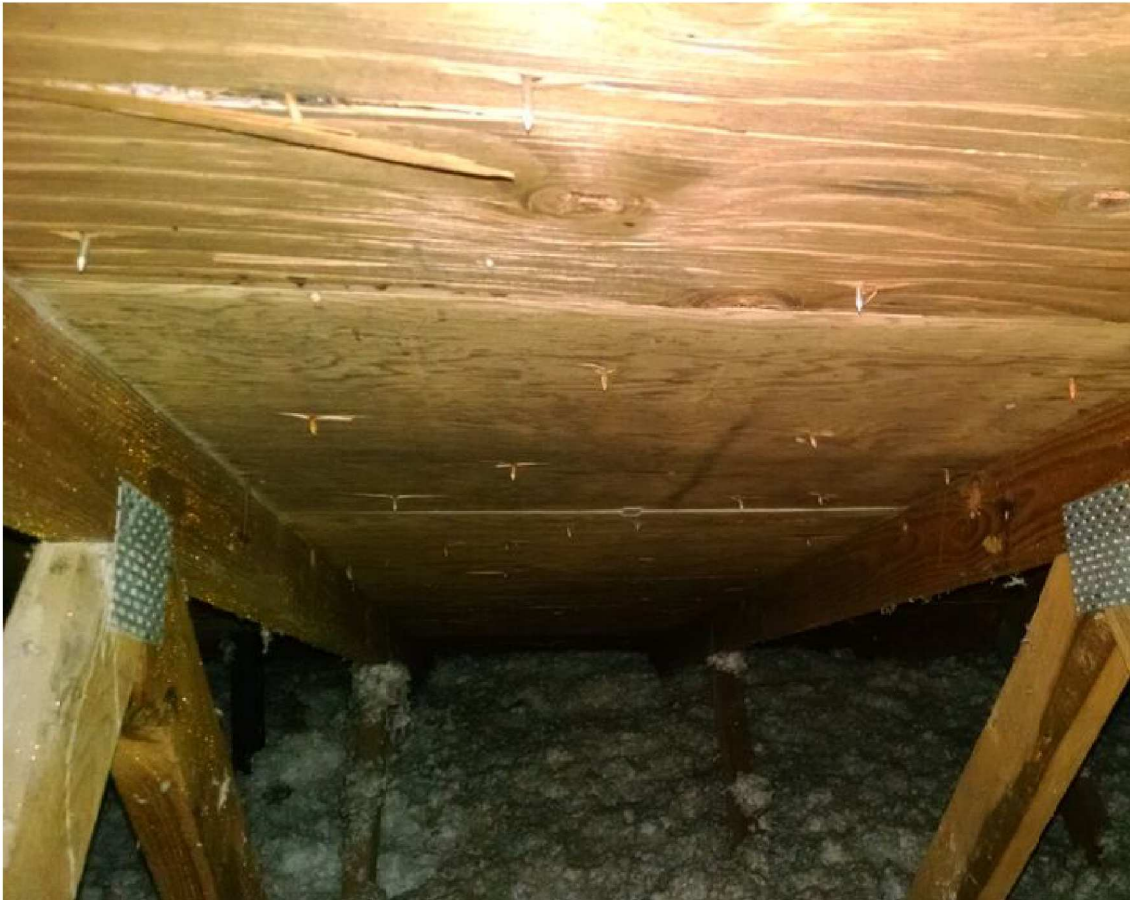
Examples of Heavy Concentrated Damage and General Damage

11. The following material that has been impacted by water and/or mold growth must be removed:
  - a. **Attic area - Impacted lumber and plywood planking:** Insulation may remain in place; however the work area platform must protect the insulation below during surface remediation. **For areas described as Heavy Concentrated Damage, sheathing material in the attic areas will have to be replaced where the plywood has shown a loss of structural integrity.** These specific areas are described above and demarcated on the attached drawings. **All visible mold on the inside of the exposed lumber areas is to be physically removed by abrasion or other appropriate means for the areas where the sheathing is not replaced and the areas described as Generalized Damage.** Dry ice blasting may prove a suitable mechanism for surface removal of mold for these surfaces. Care should be taken to avert potential scoring of wood surfaces using this technique. **Areas demarcated as un-concentrated or sporadic damage will require spot treating with a suitable abrasive material such as a wire brush or sponge and is considered a minor task.** A sealant with an active ingredient fungicide, such as Fosters 40-20 (100SF/gallon), Zinsser BIN Primer White (300SF/gallon) or Kilz 2 Latex Primer (300SF/gallon) or an equivalent, should be applied to all treated surfaces after post remediation verification testing is complete.
