Session 2.2 – Next Generation of Integrated Building Enclosures

Five Not So Easy Pieces - Designing and Building the Passive House Enclosure

This paper describes the development and execution of the enclosure system design on a multi-unit residential building designed to meet Passive House standards: The Orchards at Orenco in Hillsboro, Oregon. A highly integrated process involving heightened collaboration between the design and construction teams has resulted in an enclosure design that is constructable and cost effective, yet is expected to deliver the high level of energy performance required to meet the Passive House standard. The primary building enclosure assemblies are described and five important interface details are examined in terms of their design as well as their implementation during the construction phase of the project.

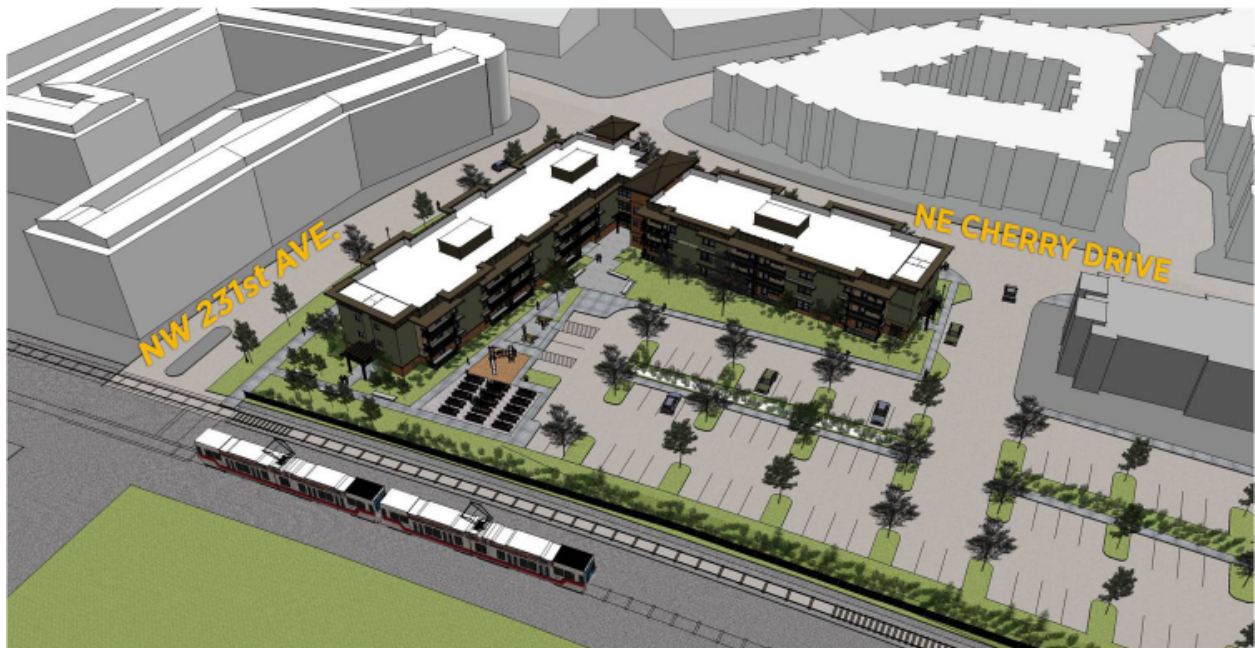
Fig. 2 - Aerial view of the site and building. Note the three penthouses at the roof which house the mechanical equipment and are included within the Passive House enclosure. Image courtesy of Ankrom Moisan Architects

The Phase I building is laid out in an L-shaped form, with two wings of residential units and a “knuckle” of common spaces at the corner (Fig. 2). Although in terms of energy efficient design the building form is not optimal from an orientation or massing standpoint, the “L” shape - and the considerable amount of articulation of the building - were required to meet design guidelines established for the Orenco Station district of Hillsboro.

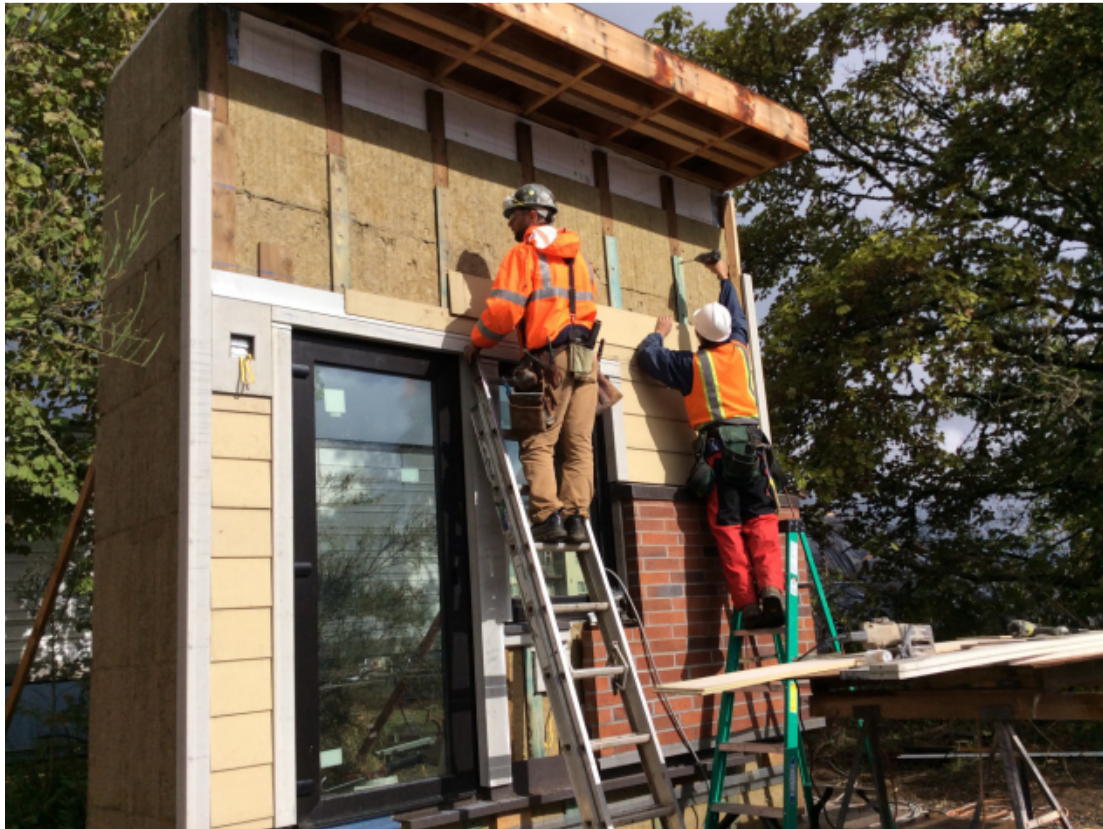
Fig. 8 - Exterior wall mockup

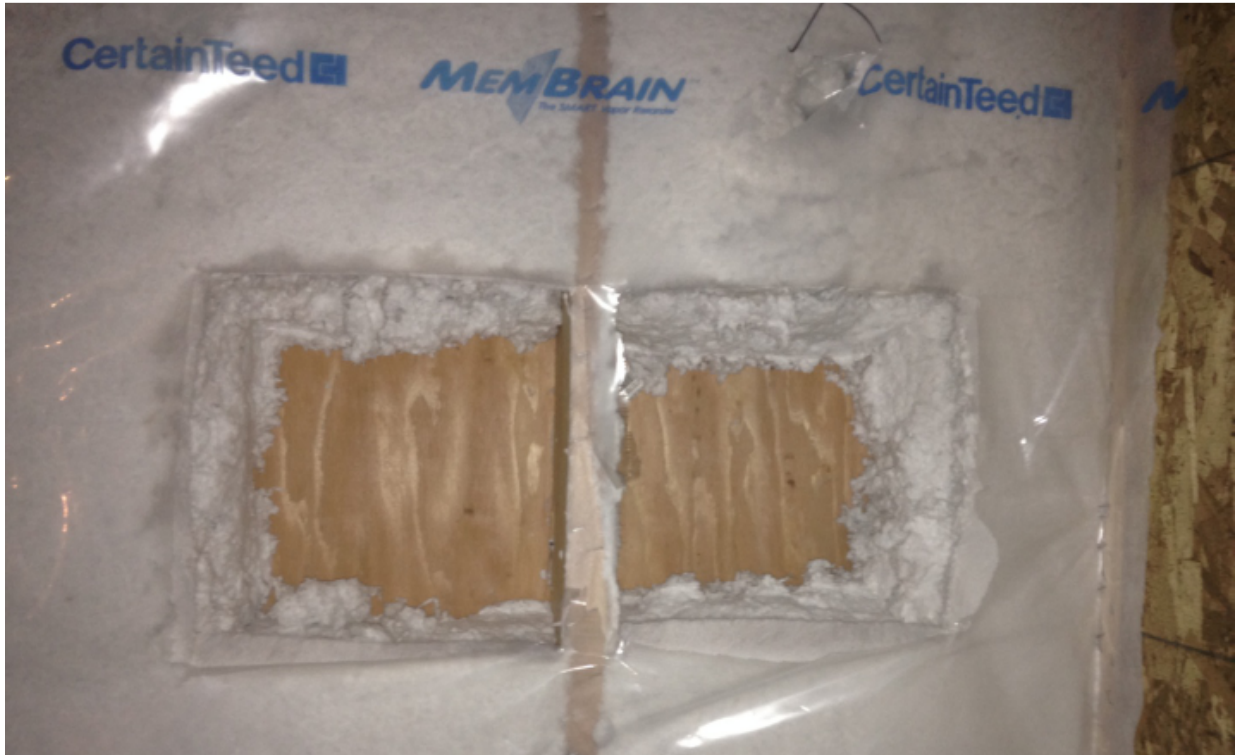
Fig. 10 - Insulation density test locations

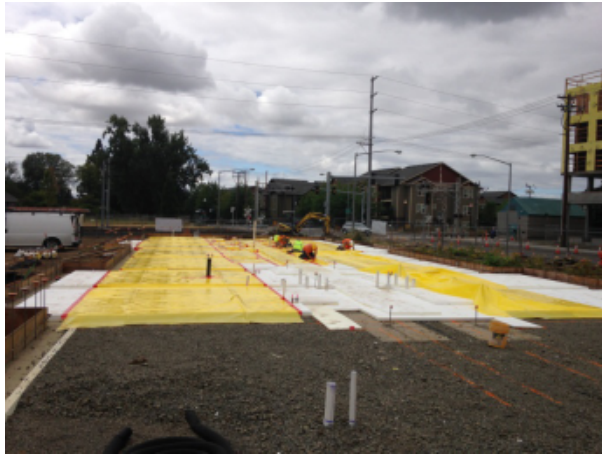
Fig. 16 - Sub-slab insulation is installed over the gravel base. Vapor barrier installation follows.

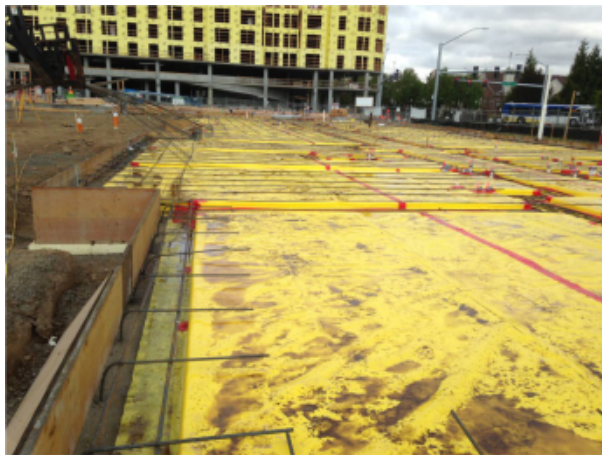
Fig. 18 - When a significant amount of rainfall occurred just prior to one of the slab pours, the team was relieved the vapor barrier had been moved to the top of the Insulation.

During execution it was found that the cold joint on the outer face of the concrete was fairly rough and did not provide a smooth substrate for applying the SAM seal, so the contractor used a grinder to smooth out the substrate to receive the SAM (Fig. 19). Primer was applied to all surfaces prior to installing the SAM to facilitate a long-lasting bond (Fig. 20). When a significant amount of rainfall occurred prior to one of the slab pours, the team was relieved the vapor barrier had been moved to the top of the insulation (Fig. 18).

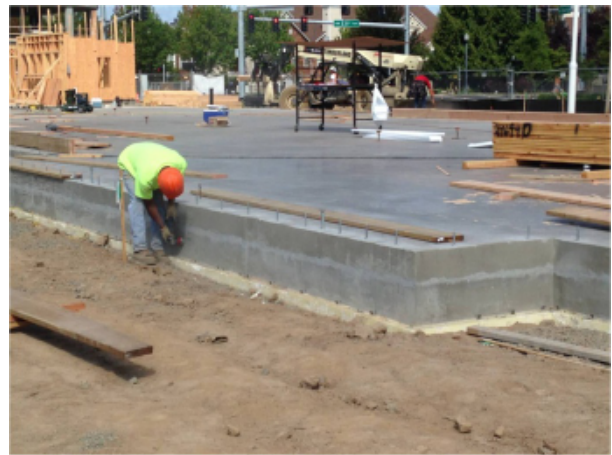
Fig. 19 - Grinding the concrete footing edge to provide a smooth and consistent substrate for application of the SAM flashing and air seal at the typical base of wall condition.

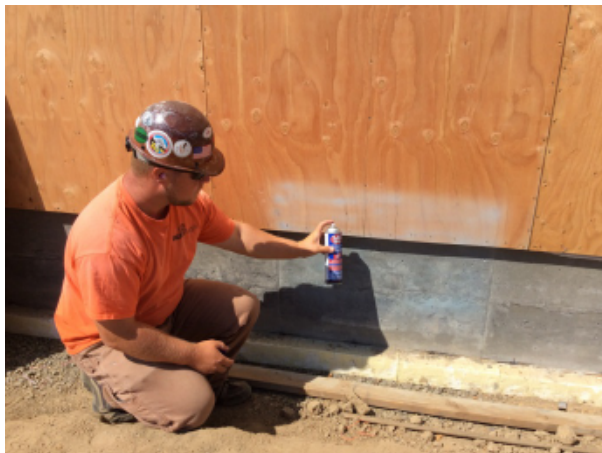
Fig. 20 - Primer is applied to the concrete prior to installation of the SAM.

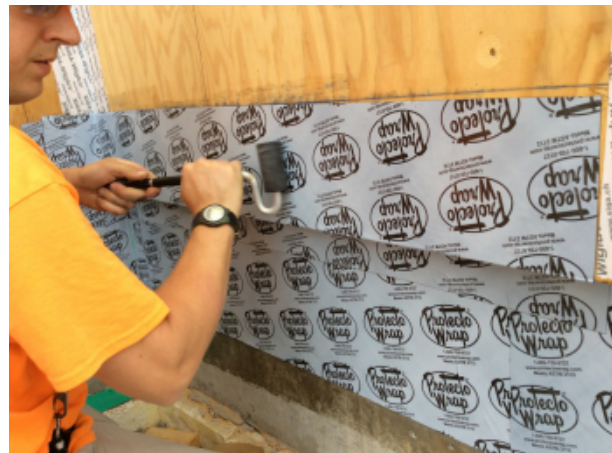
Fig. 21 - A laminate roller is used to apply pressure to the SAM to help ensure adhesion to the substrate and eliminate air pockets and pinhole leaks.

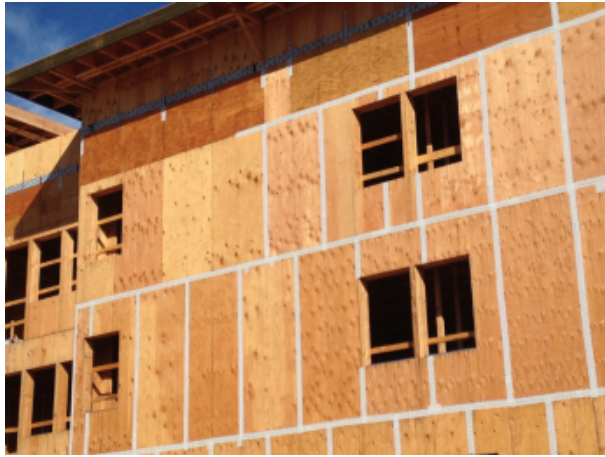
Fig. 24 - View of exterior walls prior to preparation of the window openings. The plywood wall sheathing serves as the primary air barrier material at the walls. All joints in the sheathing are sealed with tape.

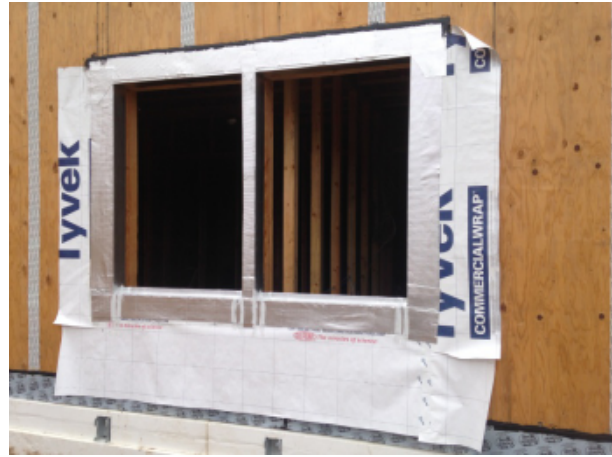
Fig. 25 - Typical rough opening preparation prior to window installation. Strips of WRB material are installed, then SAM flashing is used to wrap the openings for water management and airtightness at this crucial interface.

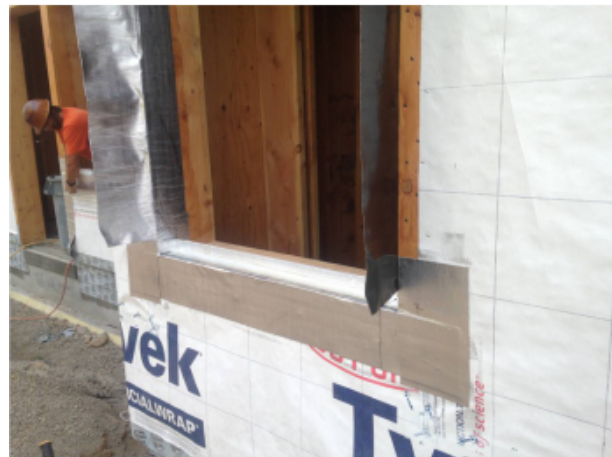
Fig. 27 - Sill pan flashing is complete. SAM flashing is applied to the jambs. SAM primer is applied to all substrate materials prior to adhering the SAM.

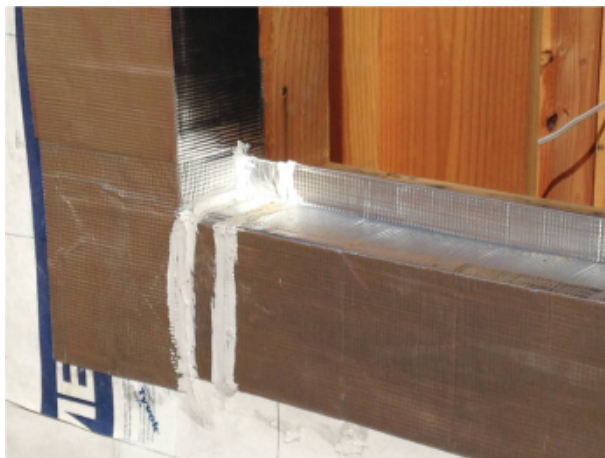
Fig. 28 - Detail view of sill pan flashing. The back leg of the pan is supported on the aluminum angle provided by the window manufacturer for attachment of the window sill.

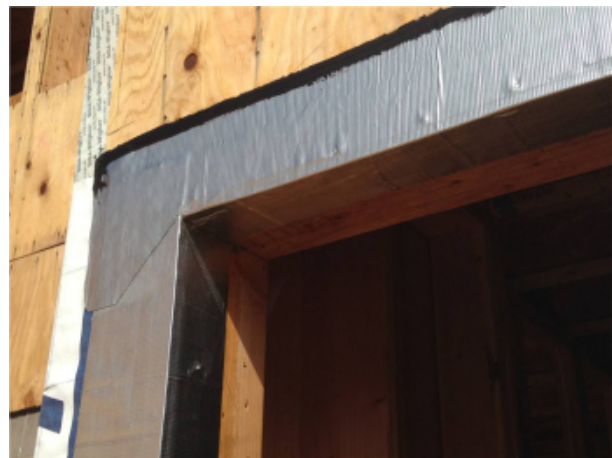
Fig. 29 - Detail view of the SAM flashing wrap at jamb and head.

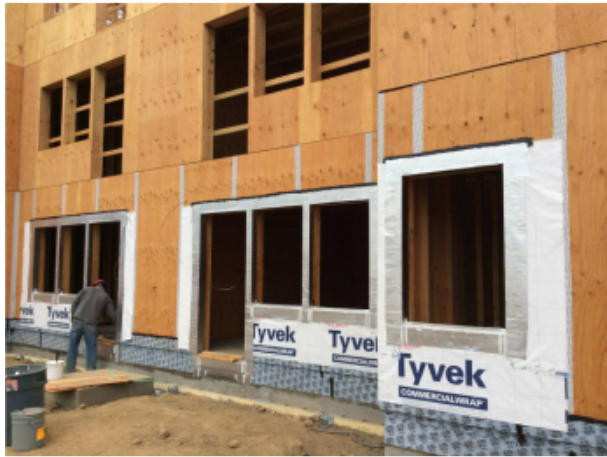
Fig. 32 - View of typical rough opening preparation at ground floor units, showing ganged windows and exterior door. This view also shows the SAM flashing and air seal applied at the base of wall.

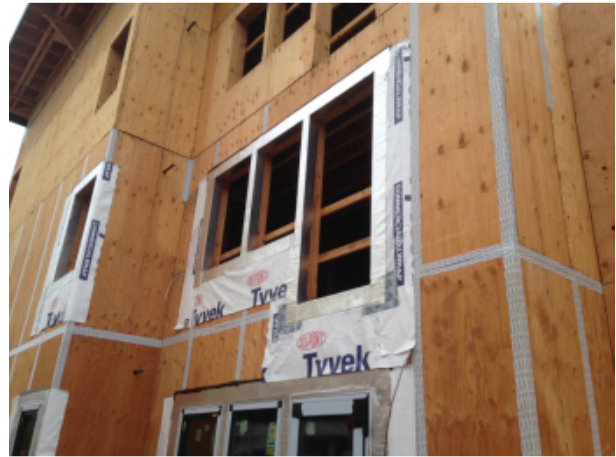
Fig. 33 - View of rough opening prep at upper floor units where balconies occur. The water-resistive barrier system will be installed and completed in its entirety prior to installing the balcony structure.

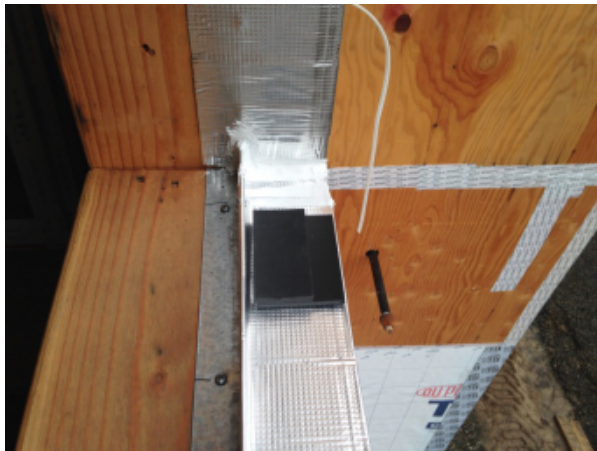
Fig. 34 - View of sill pan showing two-stage shim. This set-up allows the metal sill flashing to enter the gap between the sill pan and the window frame.

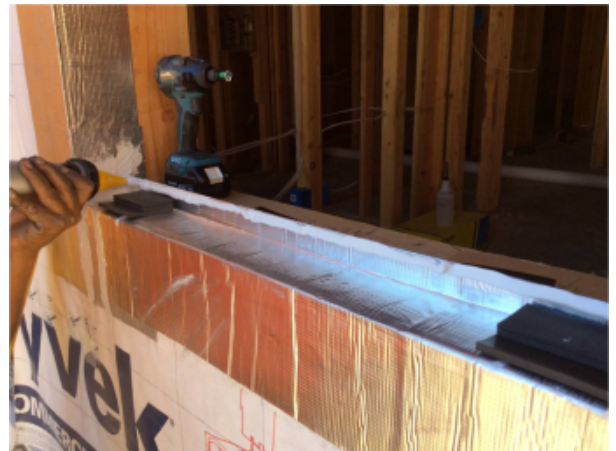
Fig. 35 - Sealant is applied to the back leg of the sill pan prior to setting window into opening.

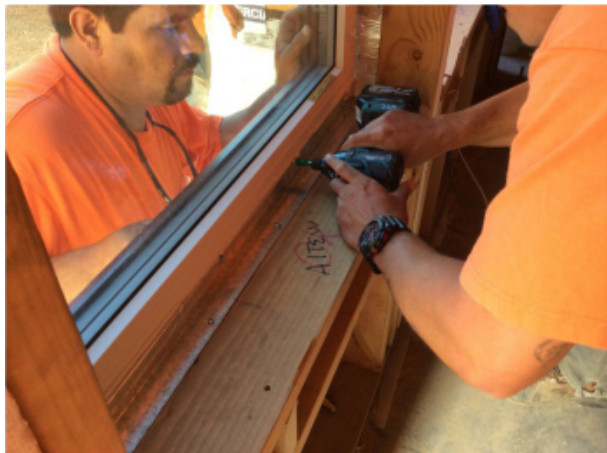
Fig. 36 - Window is fastened at the sill using an aluminum angle provided by the window manufacturer. The angle also serves as support for the SAM sill pan.

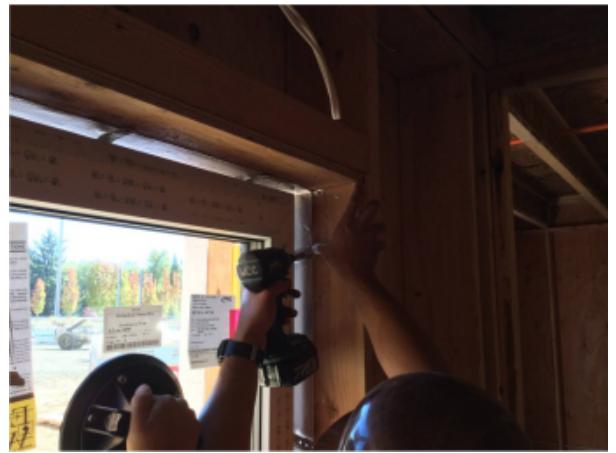
Fig. 37 - Window is fastened at the jambs and head using strap anchors provided by the window manufacturer.

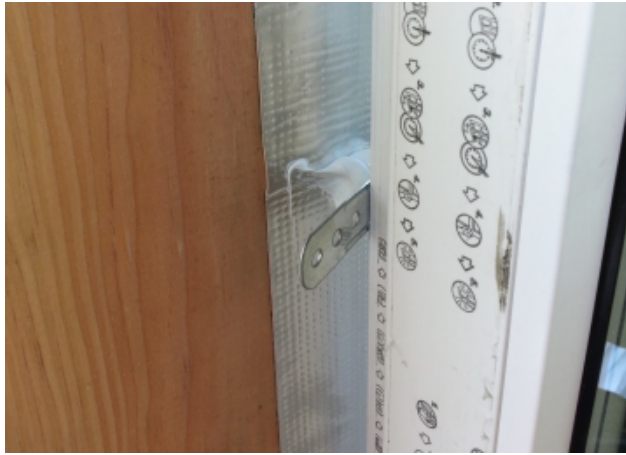
Fig. 42 - Sealant applied to strap anchor location prior to fastening. This is an important detail to encapsulate the anchor in sealant to prevent air leakage.

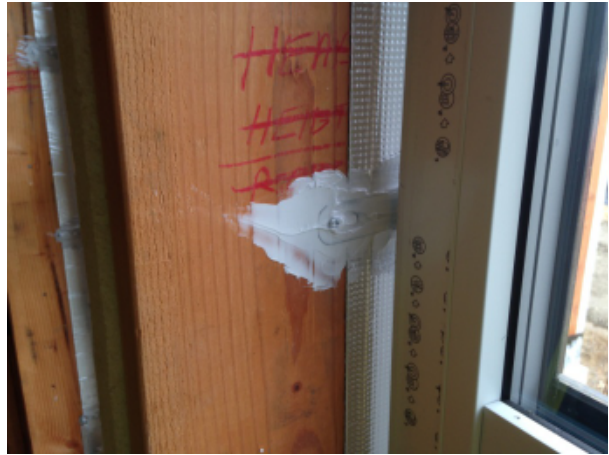
Fig. 43 - Sealant applied to strap anchor after fastening. Backer rod and sealant is subsequently installed in the gap between SAM flashing and window frame.

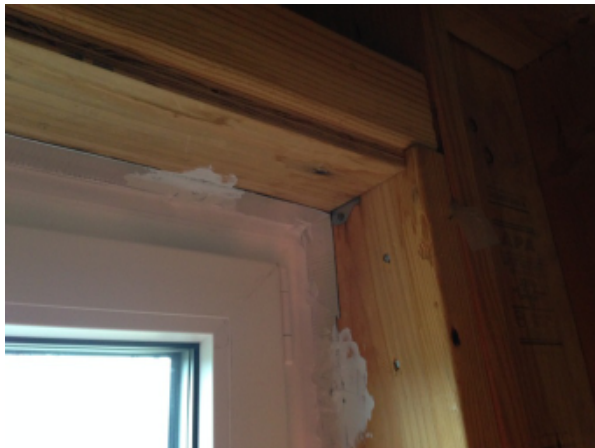
Fig. 44 - Air and water seal at interior perimeter of window. This seal completes the air barrier continuity from the wall to the window.

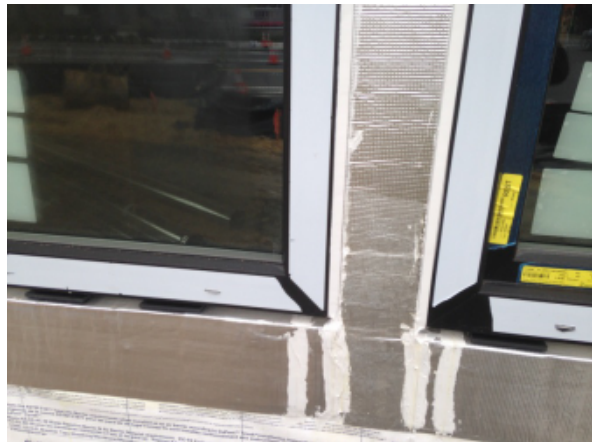
Fig. 45 - Water seal at exterior perimeter of windows. These seals occur at the jambs and head of each window. The sill is left open to allow free drainage from the sill pan area.

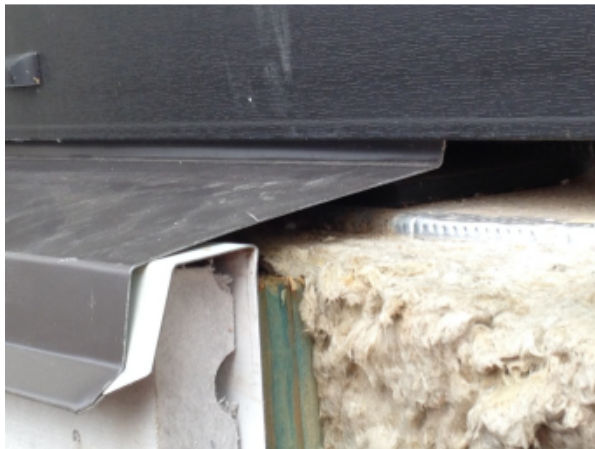
Fig. 46 - Metal sill flashing (at mockup). The flashing is inserted into cavity at underside of window frame. Bond breaker tape and sealant is then applied at the gap. The flashing is placed on the lower of the two shims to provide support and maintain free drainage from the sill pan area.

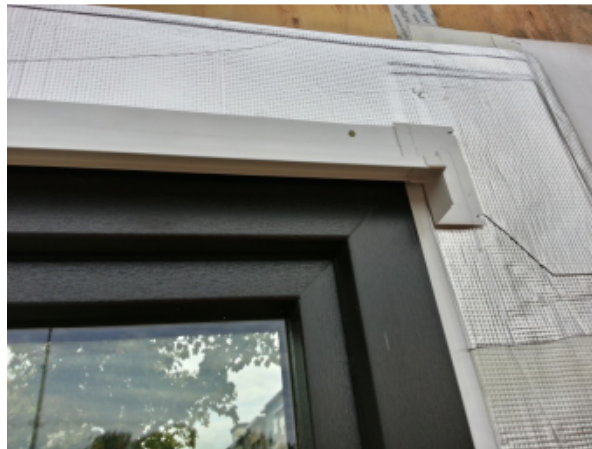
Fig. 47 - Head flashing is installed directly above the window frame. WRB from the wall area above the window is then folded down to lap over the head flashing.

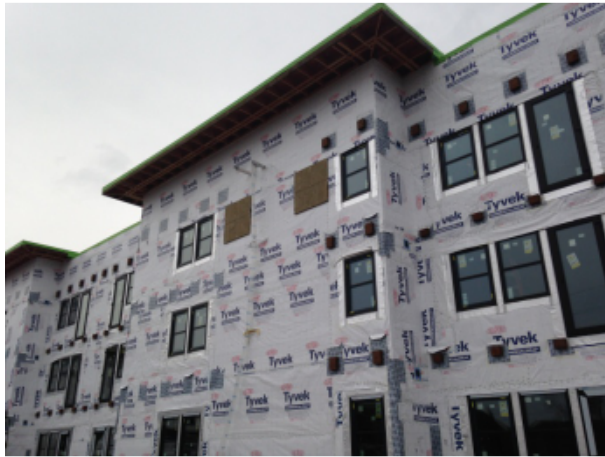
Fig. 48 - View of exterior walls after completion of the water-resistive barrier system. Treated wood blocks have been installed over the WRB at balcony ledger locations. Saddle flashing is to be installed over each block.

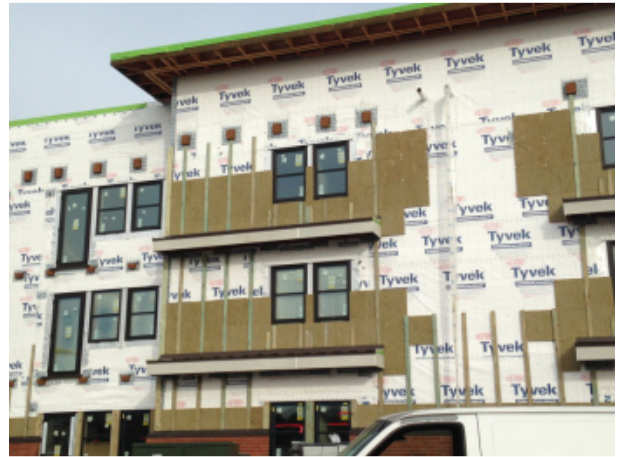
Fig. 49 - Mineral wool exterior insulation and treated wood furring installation in progress.

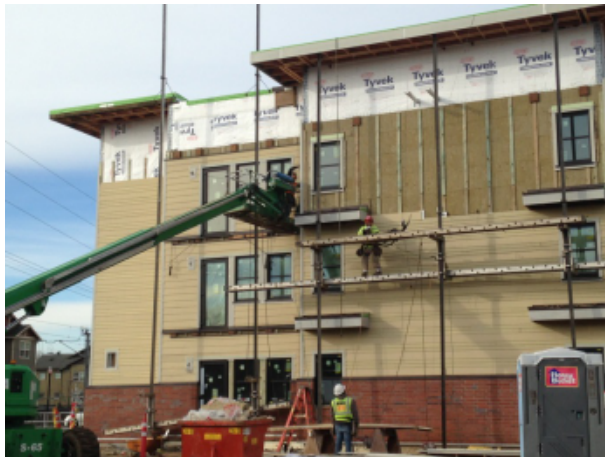
Fig. 50 - Fiber cement siding and trim installation in progress.

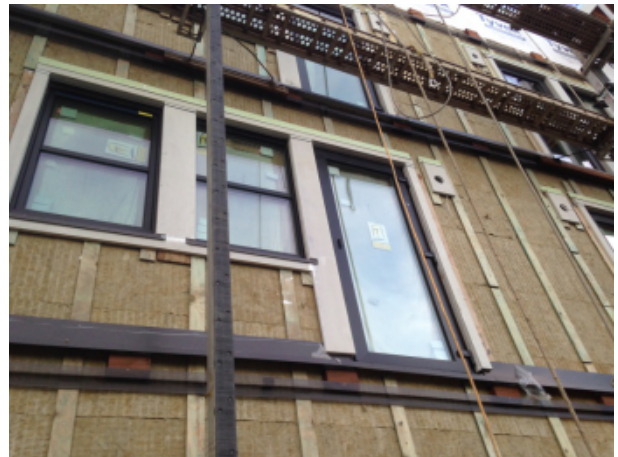
Fig. 51 - View showing trim installed prior to siding installation. Flashing and ventilation trim associated with the balcony ledger can be seen at the floor line area.

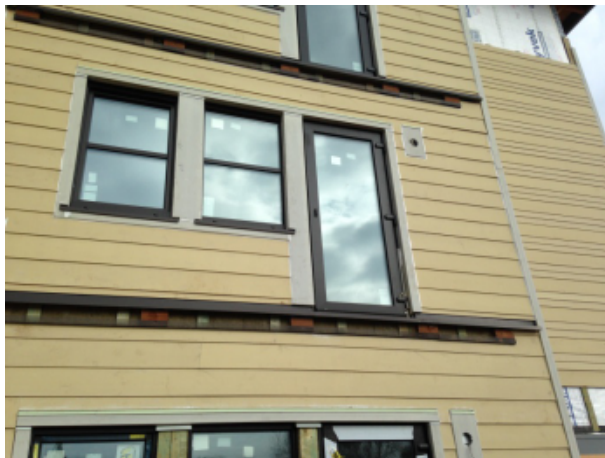
Fig. 52 - View showing similar balcony area with siding installed. Balcony ledgers will be attached to the intermittently placed wood blocks. This allows for thermal barrier continuity at the floor line area.

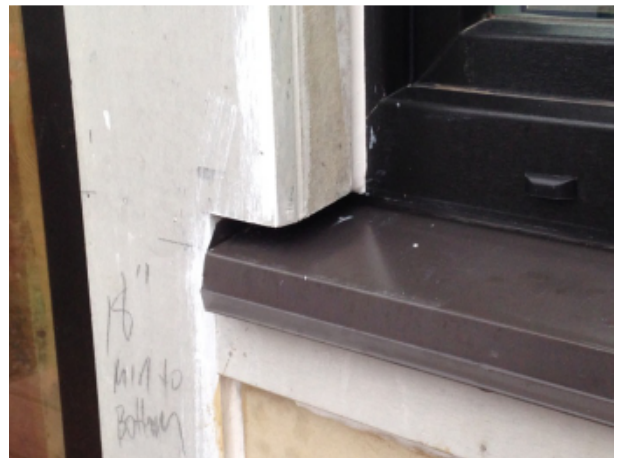
Fig. 53 - Metal sill flashing termination and fiber cement trim configuration at typical window.

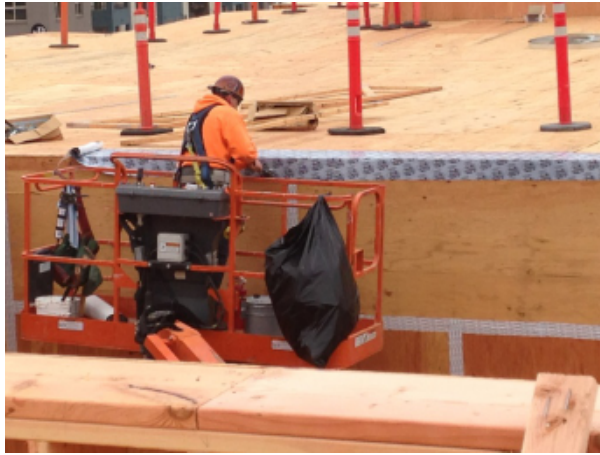
Fig. 56 - SAM is applied to interface between wall and roof. This essentially completes the seal of "the box" by connecting the wall sheathing to the roof sheathing.

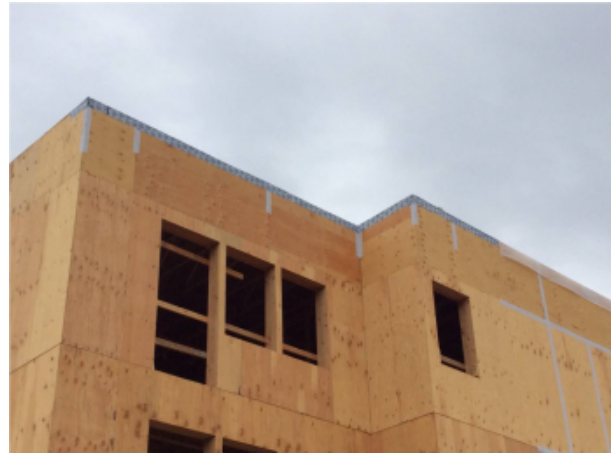
Fig. 57 - SAM seal is applied to the top of "the box." Note the poly sheeting to the right. It has been placed temporarily to keep the sheathing dry prior to installation of the membrane.

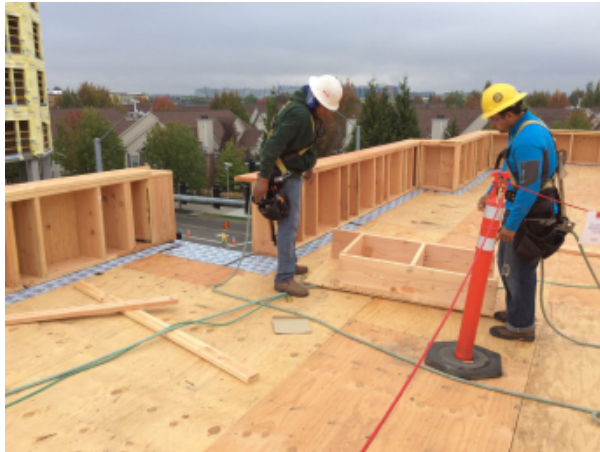
Fig. 58 - Parapet wall framing is installed over the SAM transition seal. SAM extends several inches outward from the inside of the parapet to facilitate the tie-in with the SAM vapor barrier / air barrier that will be installed later over the roof sheathing.

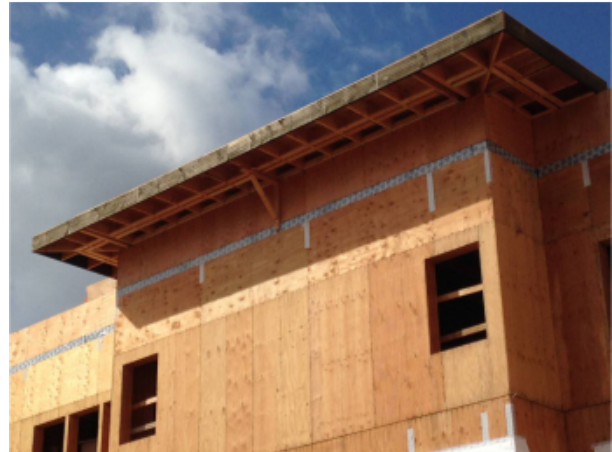
Fig. 59 - View of parapet walls framed on top of "the box." Once the joints in the wall sheathing are taped, the windows are installed and sealed, and SAM is installed over the roof sheathing, the air barrier system will be largely complete.

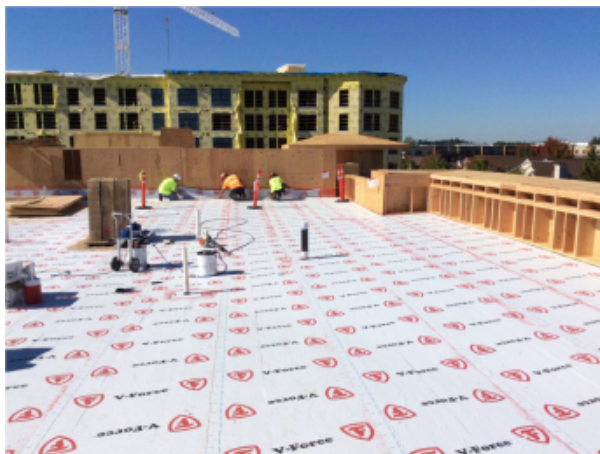
Fig. 60 - SAM vapor barrier / air barrier installed over the roof sheathing. The SAM also serves as a temporary roof prior to placement of the roof insulation, coverboard and TPO roof membrane.

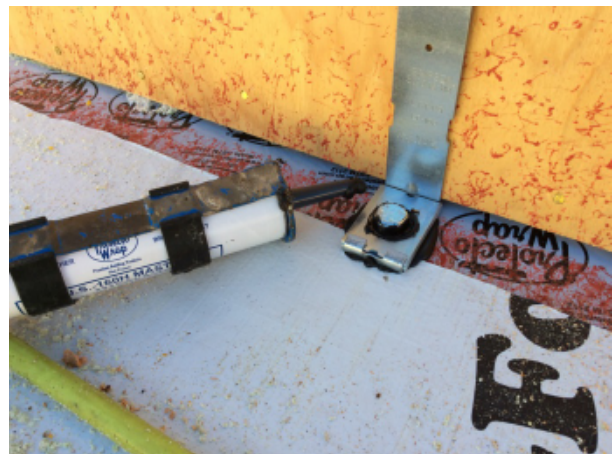
Fig. 61 - Steel strapping with large lag screws required to tie the parapet framing to the roof truss framing. These large penetrations are sealed to ensure air barrier continuity.
